Fernández Valencia, M. L., Soto Hidalgo, K. (2025). Geospatial ComSAS model to evaluate the presence of faecal *Enterococcus* as an environmental risk factor from non-point sources in creeks of the Rio Grande de Loiza, in Trujillo Alto Municipality, Puerto Rico. *GeoFocus, Revista Internacional de Ciencia y Tecnología de la Información Geográfica* (Articles), 35, 47-65.
<https://dx.doi.org/10.21138/GF.846>

GEOSPATIAL COMSAS MODEL TO EVALUATE THE PRESENCE OF FAECAL *ENTEROCOCCUS* AS AN ENVIRONMENTAL RISK FACTOR FROM NON-POINT SOURCES IN CREEKS OF THE RIO GRANDE DE LOIZA, IN TRUJILLO ALTO MUNICIPALITY, PUERTO RICO.

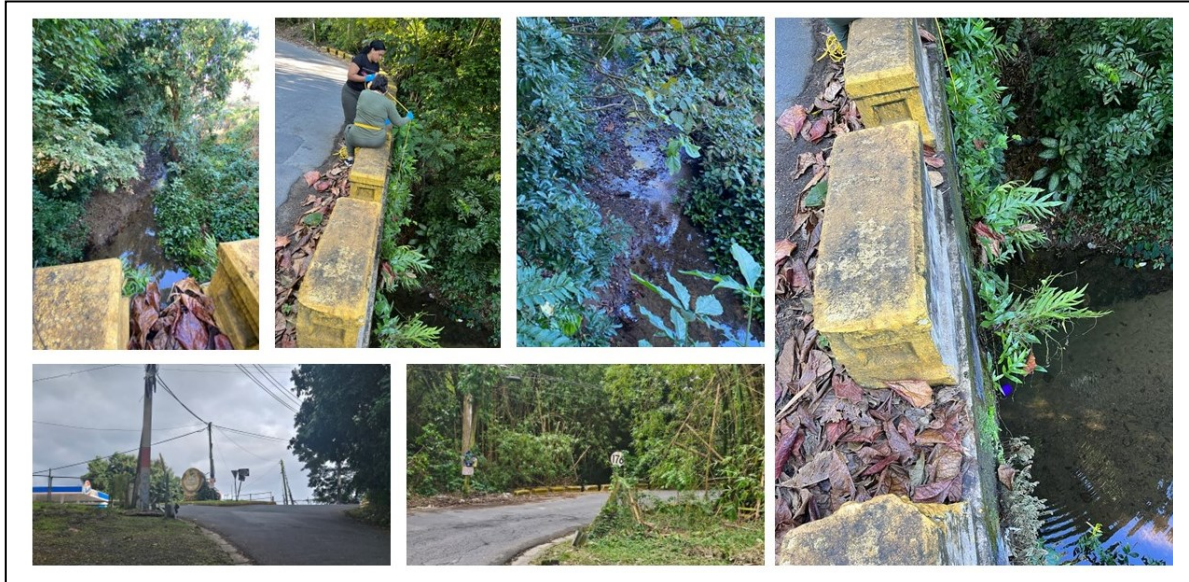
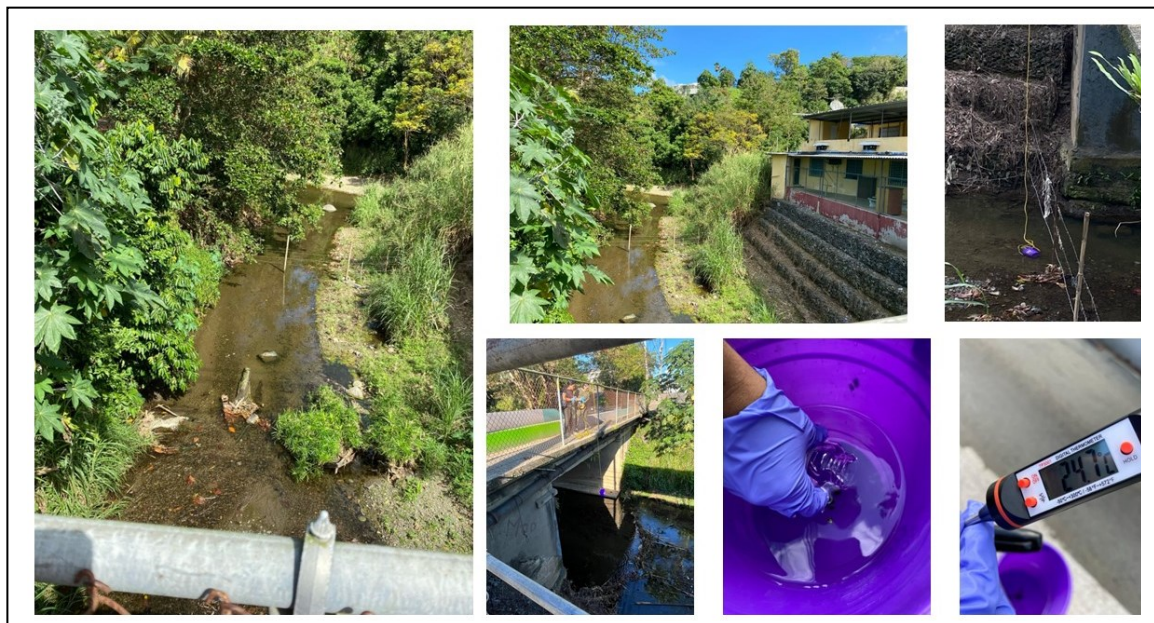
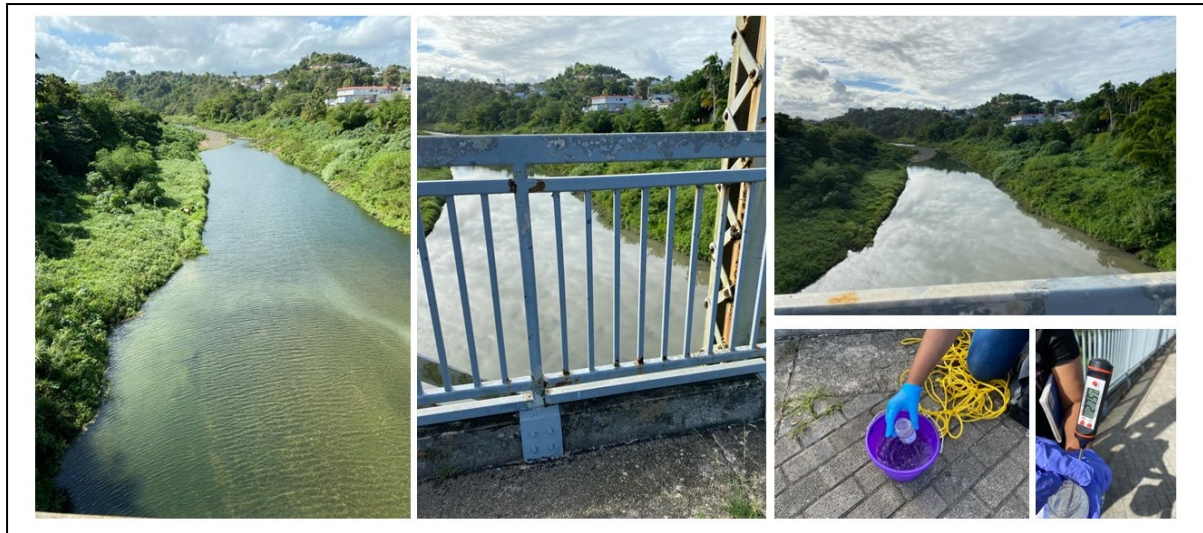
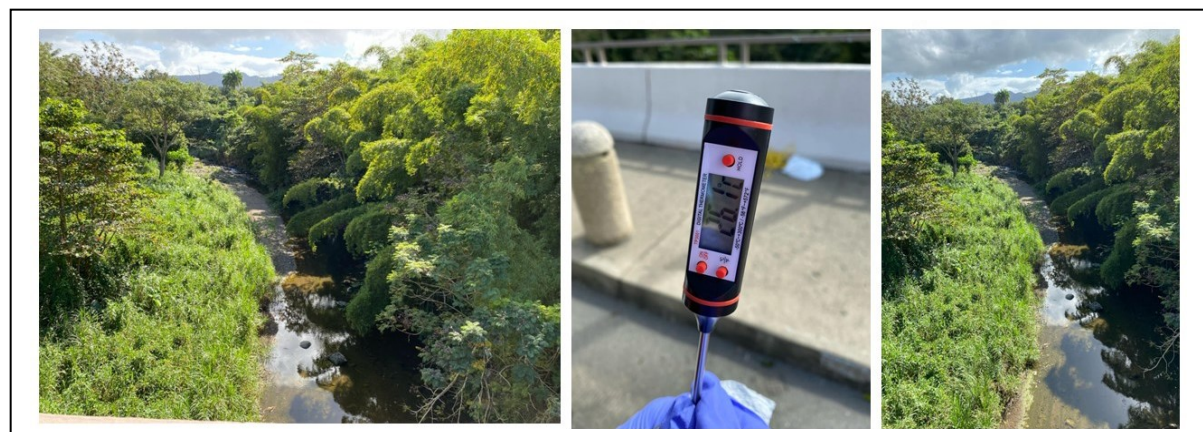
Figures 8 to 11 were taken at the river to illustrate sampling points where surface water samples were taken. In the figures it is possible to appreciate the proximity of structures to the river. The photos were taken by the researchers. The samples were taken in places where a road bridge crossed the river or creek.

Figure 8. Sampling point 1: Carraizo Creek, suburb Carraizo, in Trujillo Alto, PR.

Figure 9. Sampling point 2: Infierno Creek, suburb La Gloria, in Trujillo Alto, PR.

Figure 10. Sampling point 3: Rio Grande de Loiza, at Historic Bridge, in Trujillo Alto, PR

Figure 11. Sampling point 4: Quebrada Grande, in Trujillo in Alto Municipality.
